## A practical method to detect target failure of a helical tomotherapy unit

S. Stathakis, A. Gutierrez, C. Esquivel, C. Shi, N. Papanikolaou

Department of Radiation Oncology, University of Texas Health Science Center at San Antonio, San Antonio, TX, USA

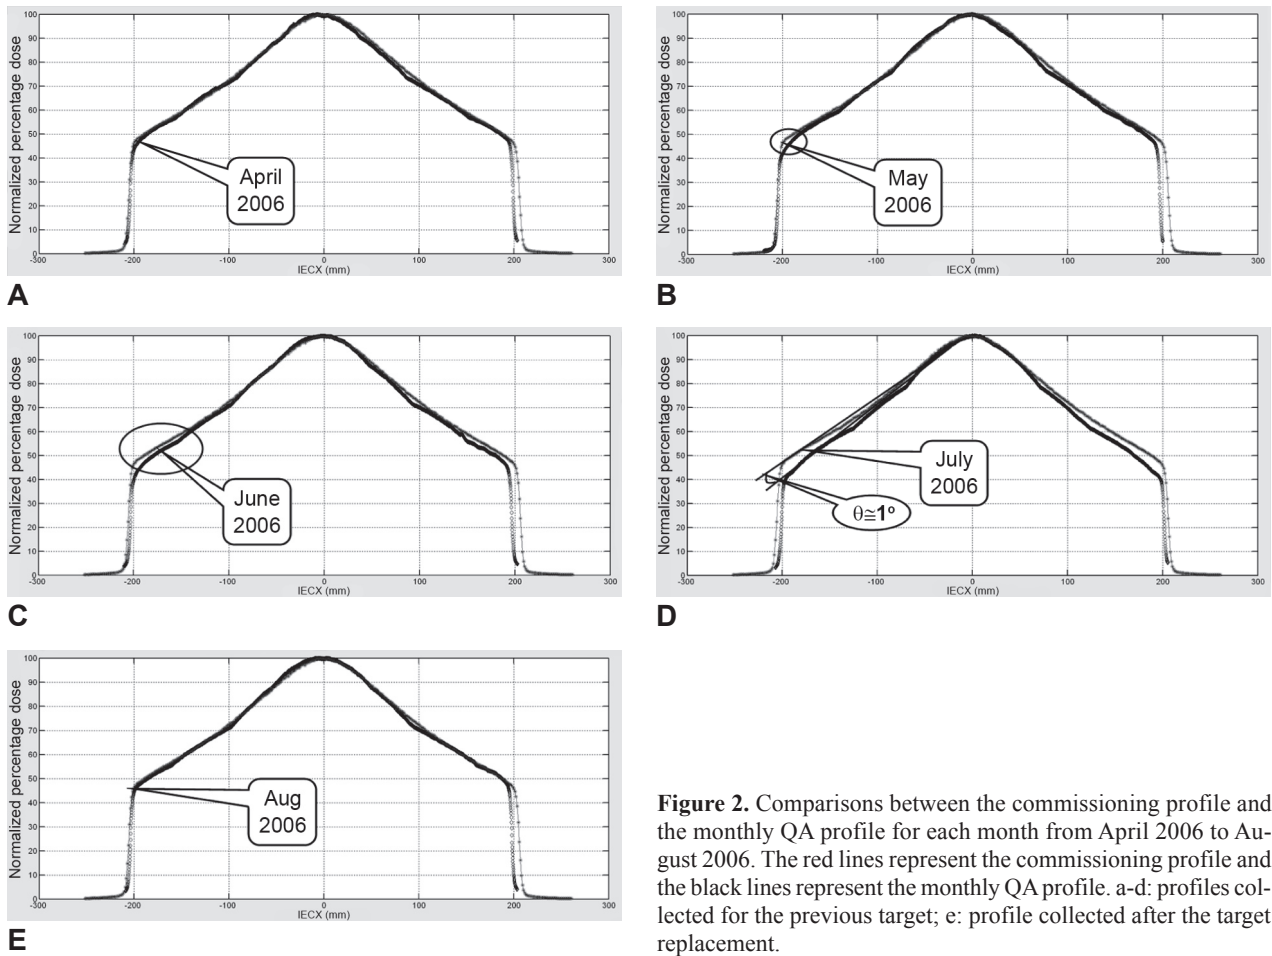
**Figure 2.** Comparisons between the commissioning profile and the monthly QA profile for each month from April 2006 to August 2006. The red lines represent the commissioning profile and the black lines represent the monthly QA profile. a-d: profiles collected for the previous target; e: profile collected after the target replacement.

From Figure 2a to Figure 2e, the change of the cross-plane profile is clearly seen. The profiles split gradually from the edge to the center as the time goes on. When the splitting angle reaches about  $1^\circ$ , it is time to replace the target. The profile splitting may be because of the slot cut into the target by the electron beam. By adjusting pulse forming network (PFN) and injection current, the intensity at the beam center is set to be the same as the commissioning status; however, the lateral beam intensity gets less than normal. This beam profile causes the measured dose profiles to split from the commission profiles.

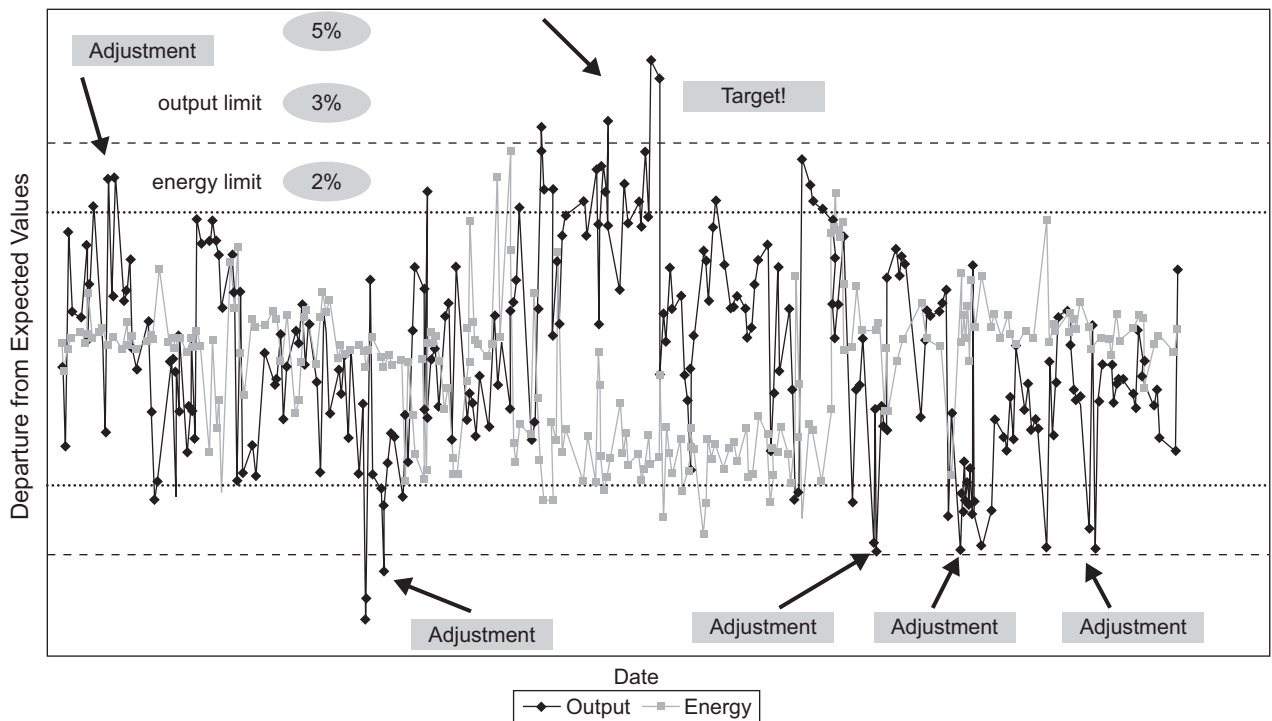
**Figure 3.** Relative daily output and energy plots for a year (November 2005 to November 2006). The outside boundary along y axis represents  $\pm 5\%$ , the dashed lines represent  $\pm 3\%$ , and the dotted lines represent  $\pm 2\%$ .

In order to double-check our finding, the daily QA trend for a whole year (November 2005 to November 2006) was plotted (Figure 3). Each time when the output or energy was over 3% off the baseline, we adjusted PFN and/or injection current to lower or increase the output or energy as explained by Balog et al.[2]. As the target was worn more, according to the daily QA trend the machine output and energy were adjusted more frequently. Both monthly profile comparison and daily QA trend can predict the target failure problem.
